# Evaluation of Settlement Quality on the Ciliwung Riverbanks: A Case Study of RW 08, Kampung Melayu Village, Jatinegara District, East Jakarta

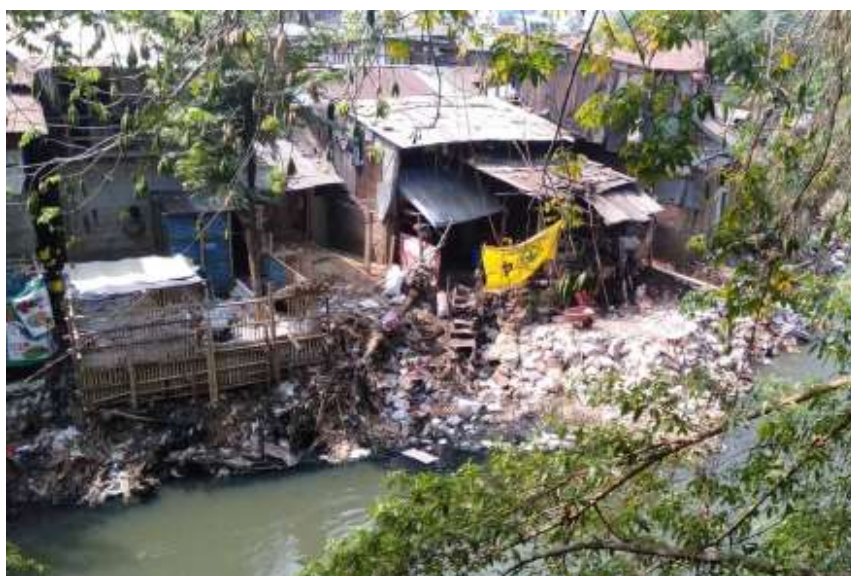
Figure 1. Condition of dense settlements on the banks of the Ciliwung River, RW 08, Kampung Melayu Subdistrict, which shows the accumulation of garbage and the decline in the quality of the residential environment.

Figure 1 shows the condition of the settlements developing along the banks of the Ciliwung River, RW 08, Kampung Melayu Village. The houses appear to be standing very close to the river, with relatively narrow distances between buildings, indicating high settlement density. On the riverbanks, there is an accumulation of domestic waste and sediment, indicating the still low quality of environmental management in the area. This condition has the potential to reduce the ecological function of the river, impede water flow, and increase the area's vulnerability to pollution and flooding. In general, this image illustrates that the environmental quality of settlements along the banks of the Ciliwung River still faces various challenges that require sustainable planning and management efforts.

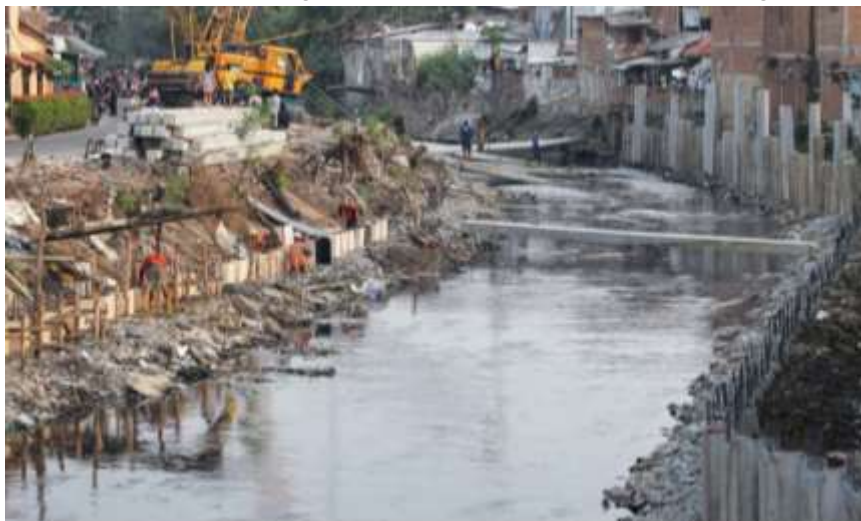
Figure 2. Condition of the Ciliwung Riverbank management in RW 08, Kampung Melayu Subdistrict through the construction of retaining walls as an effort to control flooding.  
Source: <https://megapolitan.kompas.com>

Figure 2 shows the condition of the Ciliwung Riverbanks in RW 08, Kampung Melayu Village, which are currently undergoing improvement through the construction of a retaining wall. This improvement aims to strengthen the riverbanks, reduce the risk of erosion and flooding, and improve the quality of the residential environment in the riverbank area. However, dense residential conditions remain a challenge in creating a safe, healthy, and sustainable residential environment.

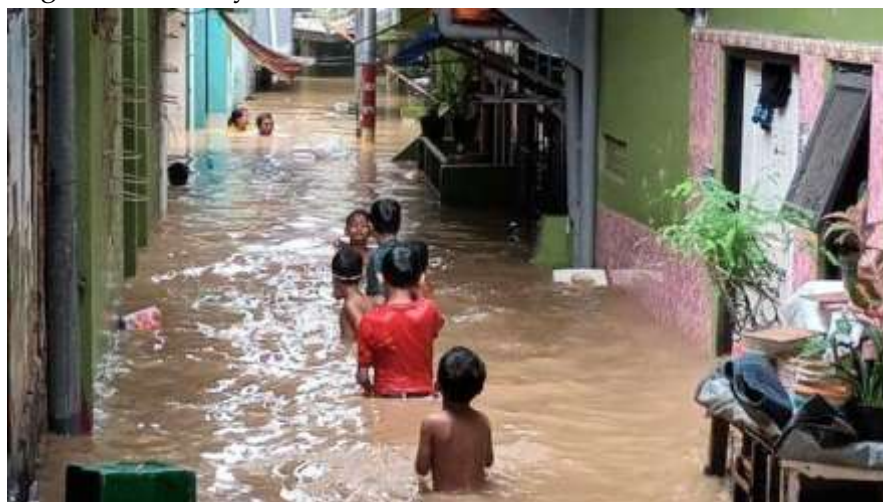
Figure 3. Flood conditions in residential areas along the banks of the Ciliwung River which affect accessibility, community activities, and the quality of the residential environment.

Figure 3 shows the condition of the settlement in RW 08, Kampung Melayu Village, which experienced flooding due to the overflowing Ciliwung River. The floodwaters have entered neighborhood roads and residential areas, disrupting community activities and reducing area accessibility. This condition indicates the high level of vulnerability of the settlement to flooding, influenced by the area's location on riverbanks, building density, and limited drainage capacity. In addition to impacting community social and economic activities, flooding also has the potential to reduce the quality of environmental sanitation, increase the risk of spreading environmentally-based diseases, and accelerate damage to settlement infrastructure. This phenomenon indicates that improving the quality of settlements requires not only improvements to physical infrastructure, but also area management that can increase settlement resilience to flood risks.

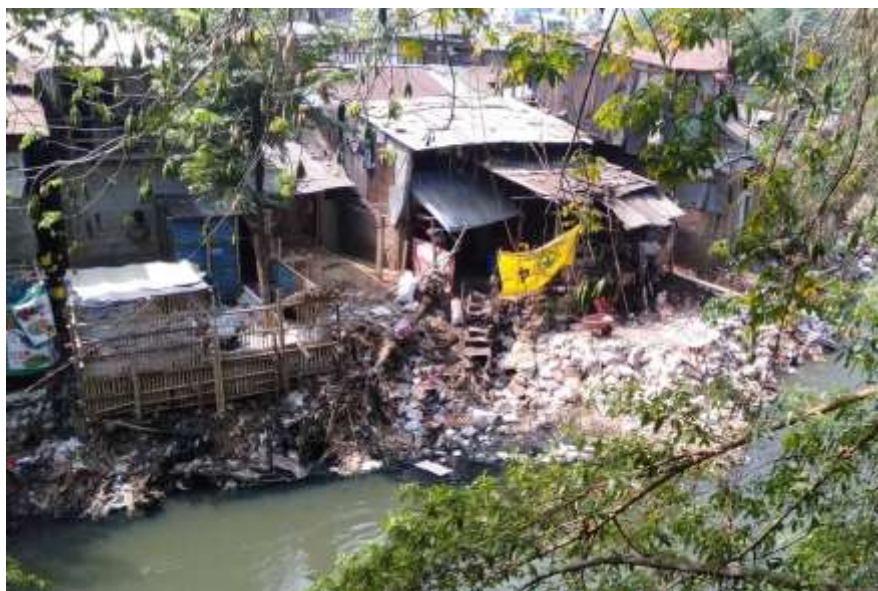
Figure 4. Distance between buildings and river

Observations indicate that buildings in RW 08, Kampung Melayu Village, are dominated by permanent structures with brick walls and tile or zinc roofs. However, some buildings are still located very close to the Ciliwung River, thus failing to meet the principles of safe river boundaries. Based on the assessment, the building condition indicator scored 40, categorizing it as unsuitable. However, several buildings still require quality improvements, particularly regarding safe distances to the river and building layout.

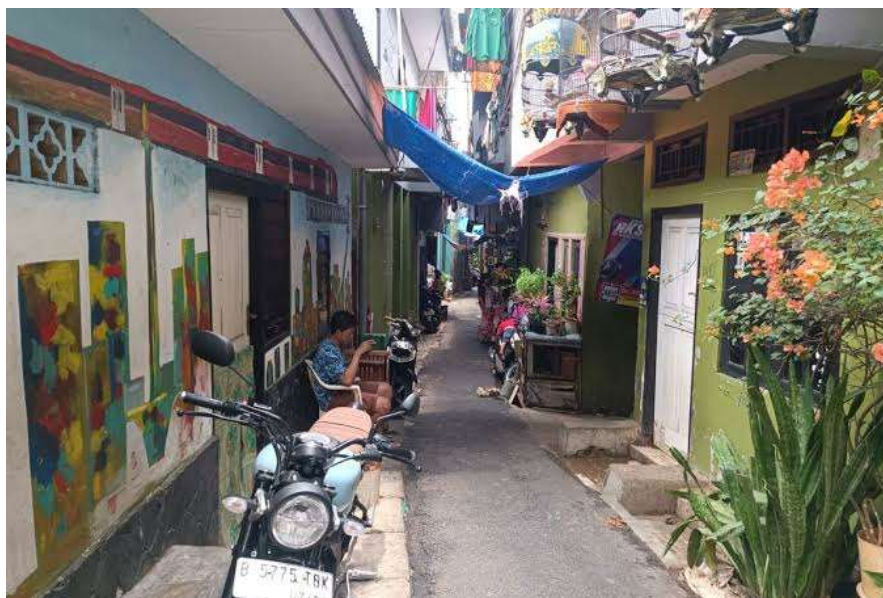
Figure 5. Road in the Ciliwung River area

Based on observations, the neighborhood roads in the study area are paved, facilitating community mobility. However, the road width in some sections is still limited, making emergency vehicle access difficult. The neighborhood road indicator scored 60, categorized as good.

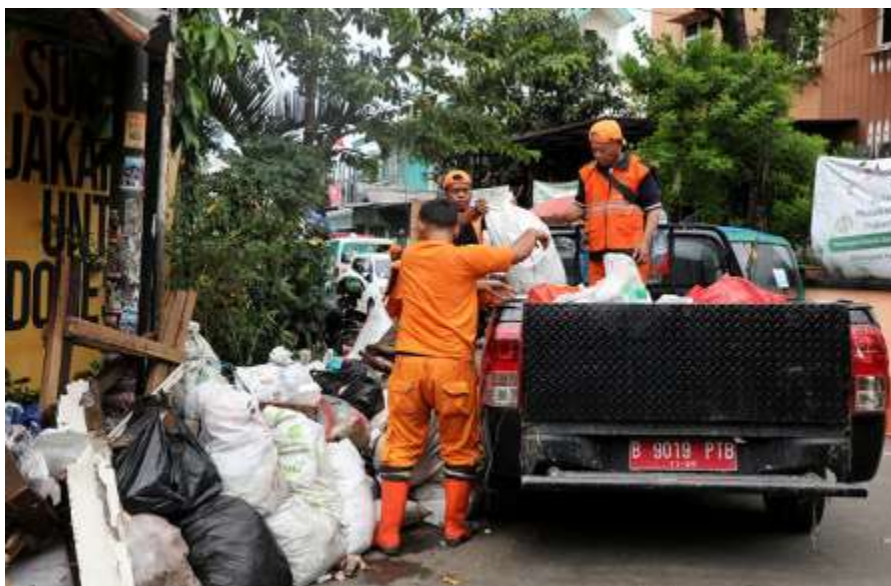
Figure 6. Mobile Waste Management in the Ciliwung River Area

Waste management remains an area requiring attention. Observations show accumulation of waste along several riverbanks, indicating that the waste management system is not functioning optimally. This indicator received a score of 60, which is considered moderate.
